DELAWARE RIVER BASIN,  
Tributary of Mill Creek, Berks County,  
Pennsylvania. Phase I Inspection Report,  
SCS PA 476  
BERKS COUNTY, PENNSYLVANIA

NDS I.D. NO. PA 00719  
DER I.D. NO. 6-456

PHASE I INSPECTION REPORT  
NATIONAL DAM INSPECTION PROGRAM

WOODWARD-CLYDE CONSULTANTS  
5120 Butler Pike  
Plymouth Meeting, Pennsylvania 19462

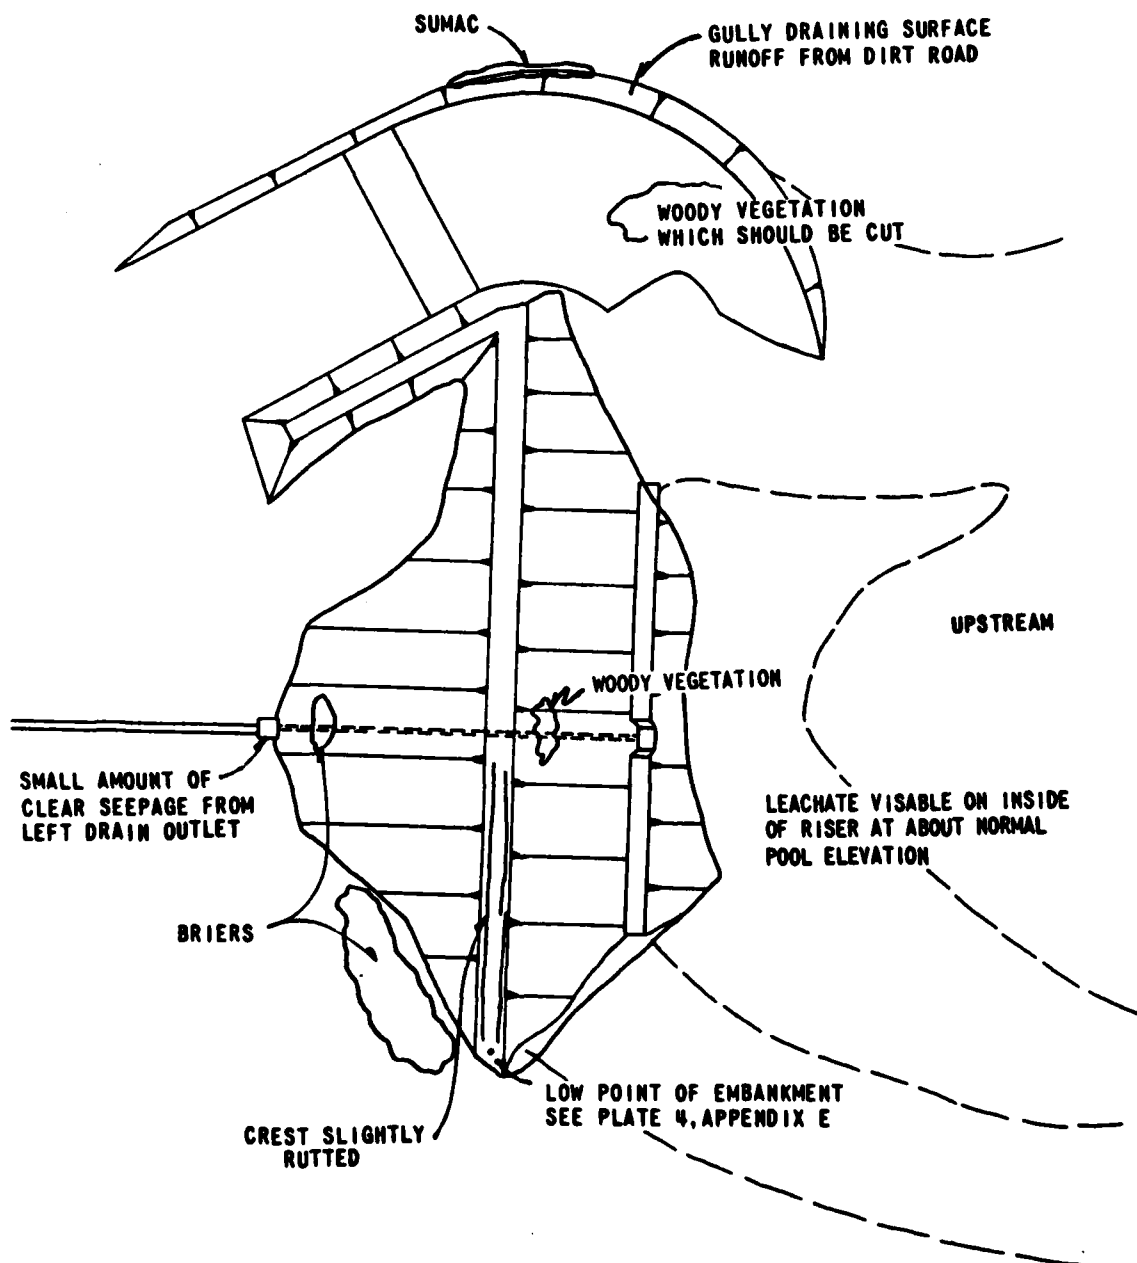
SHEET 5A OF 11

FIELD OBSERVATION PLAN  
SCS PA 476

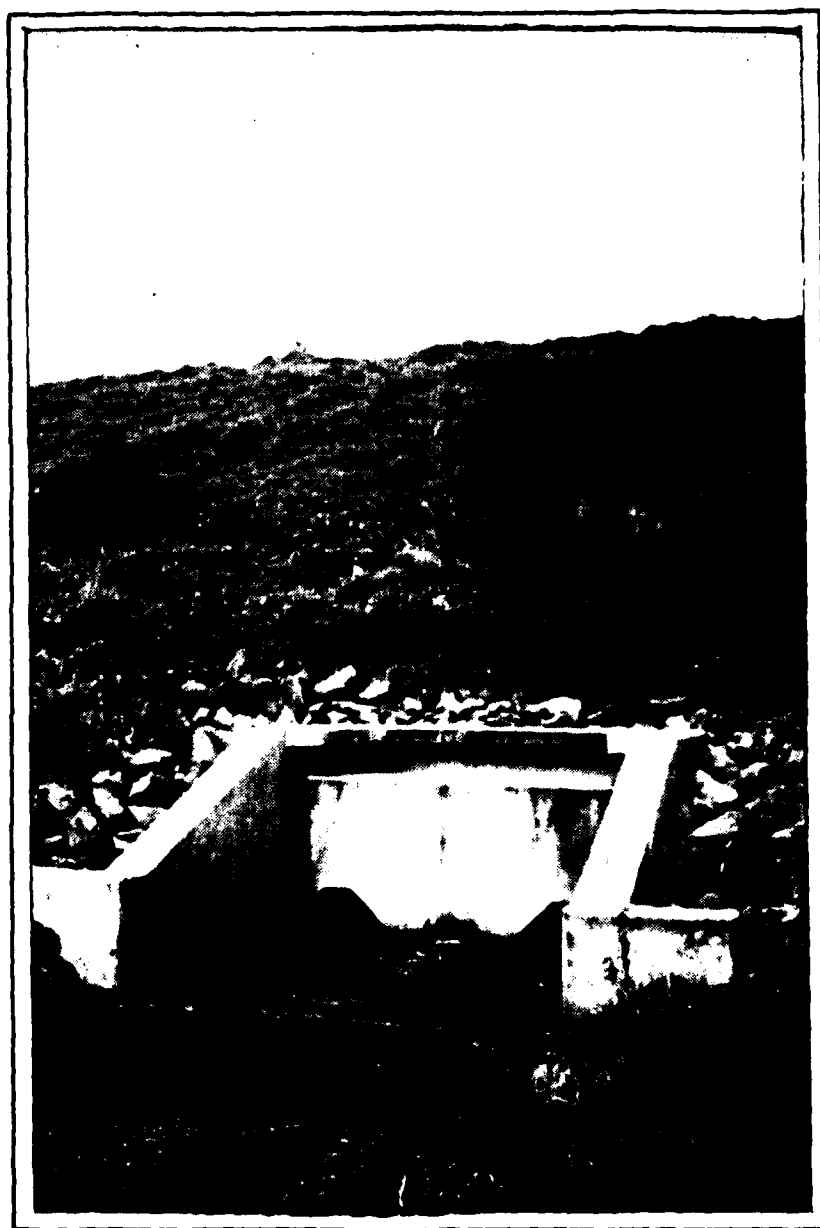
PHOTOGRAPH NO. 3

excessive concrete deterioration, spalling or other structural deficiencies or defects. Inspection of the inside of the riser from the top of the riser through the access gate door disclosed a small amount of leachate visible on the inside of the riser at about normal pool elevation. The pond drain sluice gate located on the outside of the riser operates easily. The outlet channel was inspected and observed to be in good condition with no excessive erosion or bank undercutting. The impact basin, Photograph No. 3 in Appendix C, was found to be in good condition.

IMPACT BASIN AT DOWNSTREAM TOE. NOTE  
WEEDS AND BRIERS ON DOWNSTREAM SLOPE.

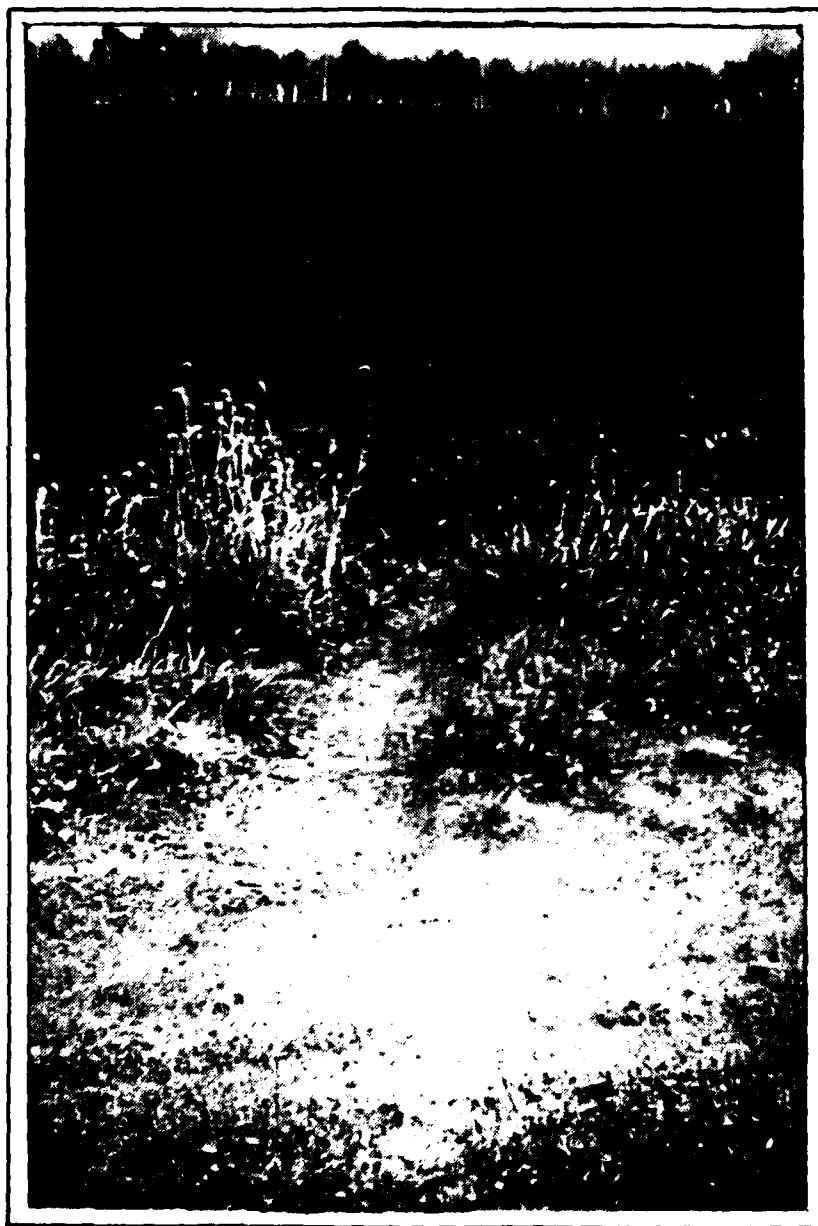
PHOTOGRAPH NO. 10

VIEW OF GULLY DRAINING SURFACE  
RUNOFF FROM DIRT ROAD INTO  
EMERGENCY SPILLWAY.

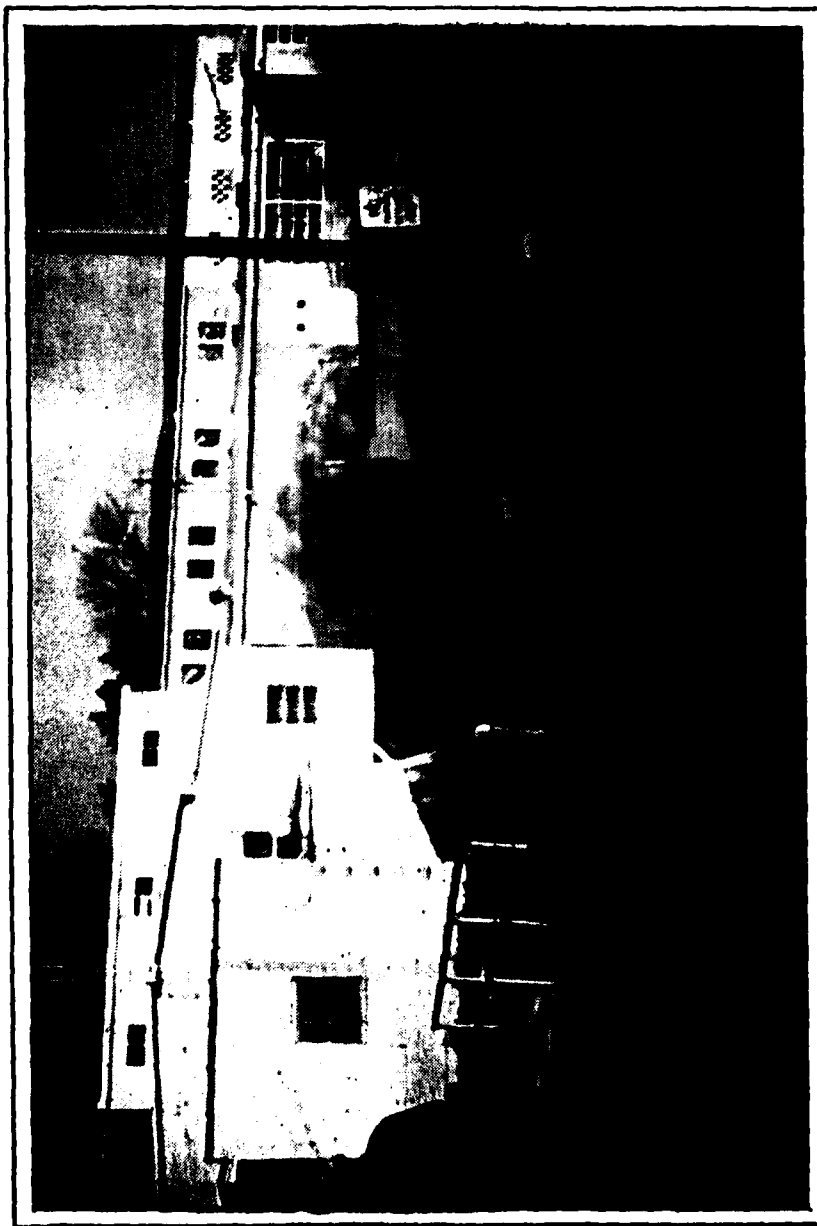
PHOTOGRAPH NO. 13

TYPICAL VIEW OF DOWNSTREAM DAMAGE  
CENTER IN HAMBURG, PENNSYLVANIA.
